PCB Hazards in Upstate South Carolina Drinking Water

South Carolina, USA

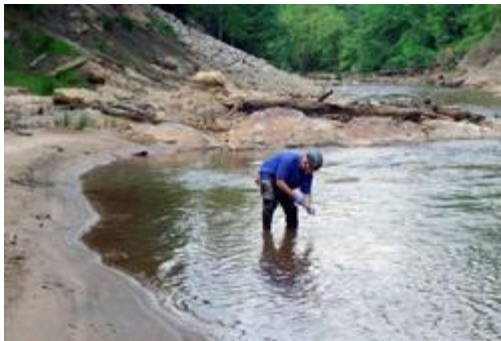
Figure 1 EPA Employee Testing Water for PCB in Twelve Mile Creek, SC (Courtesy EPA)

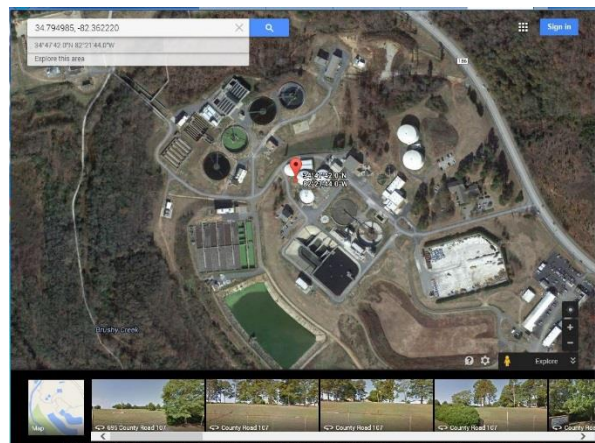
Figure 2 Google Maps Location of the Mauldin Road Sewage Treatment Plant

This project required a large amount of data collection from many sources. First political data showing the locations of cities and counties for the entire state of South Carolina had to be gathered. Then environmental data showing lakes, rivers, and watersheds had to be added to the dataset. The the location of EPA water monitoring stations had to be gathered, as well as the locations of all contaminated sewage treatment plants. The treatment plants were difficult, as the facility names were released to the press when contamination was found, but not the locations of the plants themselves were given. Occasionally a city or road was listed, but the coordinates of all five plants had to be found manually using google maps. The general area was taken from press releases and satellite view in google maps was used to find the characteristic appearance of a sewer treatment facility. A point was then made at the area and the coordinates recorded in a Microsoft excel table. These points will be revisited in

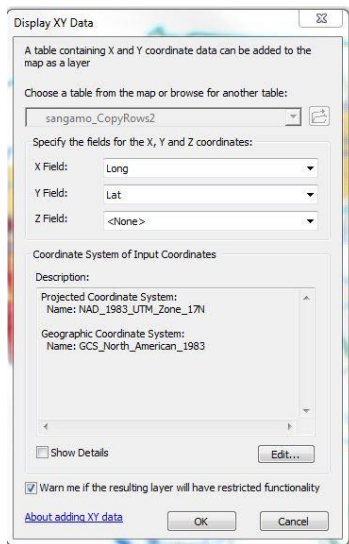
Figure 3 Display XY Data Screen

The water treatment plant locations, Sangamo Weston plant location, and the contaminated sludge applications were not in an ArcGIS readable format and had to be converted. Luckily, as they were all saved in CSV format tables, the same procedure was used to convert all three datasets. Because I compiled the Sangamo Weston location and water treatment plant location in excel tables, the tables were saved as CSV tables. I then used the Table to Table Conversion tool in ArcToolbox to convert the CSV tables and add them to my table of contents in ArcMap. In the table of contents, I then had to right-click on the imported table and select “Display XY Data.” On the input screen that then appears, I had to change the coordinate system for the points to NAD 1983 so that the points would be projected in the same coordinate system as the rest of my map. After selecting the new coordinate system and selecting “OK,” the points were displayed on my map.

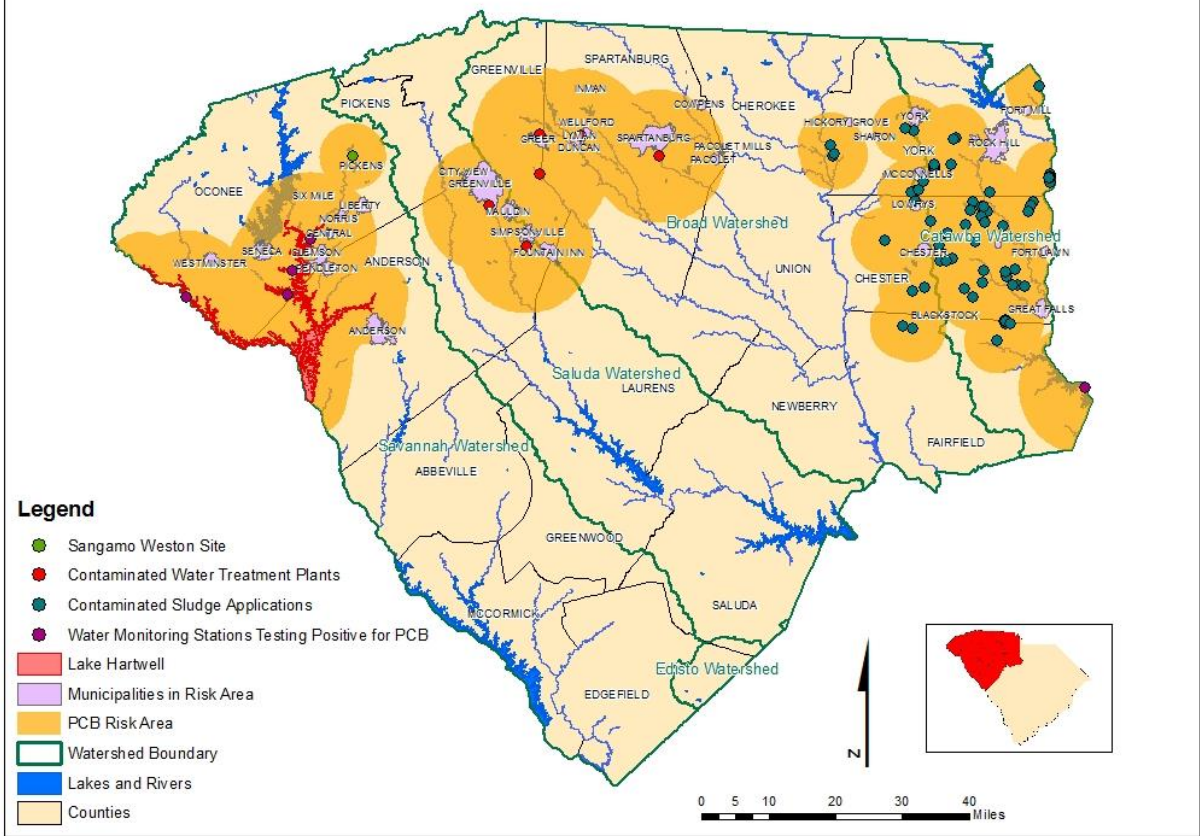
PCB Hazards in Upstate South Carolina Drinking Water, South Carolina, USA

“Municipalities in Risk Area” layer and labeled the cities and towns. Finally, I cleaned up the map, added labels to watersheds and counties, a neat line, title, scale, north arrow, legend, and also created an image to show where the counties are located with respect to the rest of the state.
